# Manhole Inspection Summary

Manhole # S33A\_\_023MH

Insp Date: **4/22/08 1:23 PM**

**Location** Address: **400 CATHEDRAL ST**

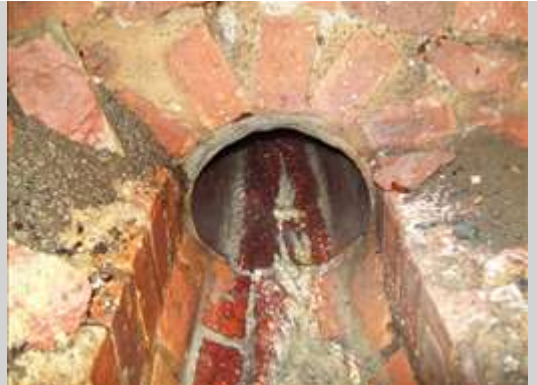
12 O'Clock Outflow

8 in. Circular Gravity Sewer  
Pipe Out @ 12 O'Clock

Pipe Material: **Clay** ☐ Pipe Lined

Invert Depth: **30.41** (ft.) Flow Characteristics: **Slow**

Deposits: ☒ None ☐ Mud ☐ Sludge ☐ Debris ☐ Grease

Infiltration: **None** Pipe Seal Cond: **Sound**

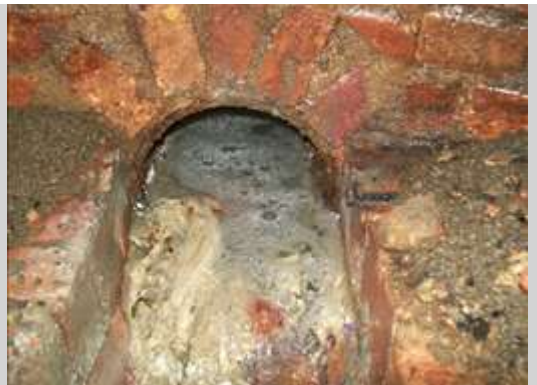
3 O'Clock Inflow

8 in. Circular Gravity Sewer  
Pipe In @ 3 O'Clock

Pipe Material: **Clay** ☐ Pipe Lined

Invert Depth: **30.01** (ft.) Flow Characteristics: **Slow**

Deposits: ☒ None ☐ Mud ☐ Sludge ☐ Debris ☐ Grease

Infiltration: **None** Pipe Seal Cond: **Sound**
